## A Modern Approach To Clavicle Fractures

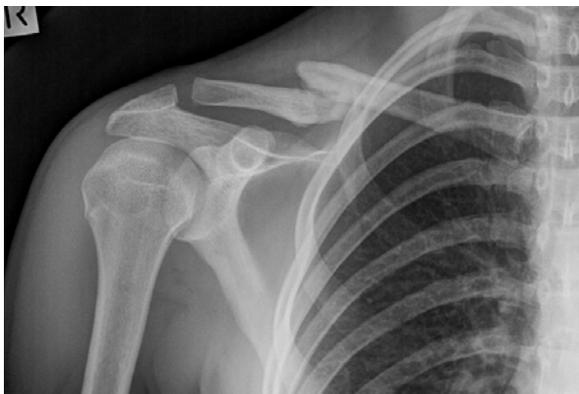
Figure 1. A midshaft clavicle fracture with 1cm shortening and minor comminution (small fragments as well). Either operative or non-operative management is reasonable.

The most common fracture is about halfway between the two ends of the bone (figure 1). These typically have a degree of overlap. The overlap does not prevent the bone from healing. If there is more than 2cm of shortening it can potentially change the function of the shoulder. Also, there may be cosmetic imperfections, as one shoulder tip visibly doesn't sit as far out as the normal one. Non-operative treatment with a brace strapping the shoulder out (figure 2) will reduce this.

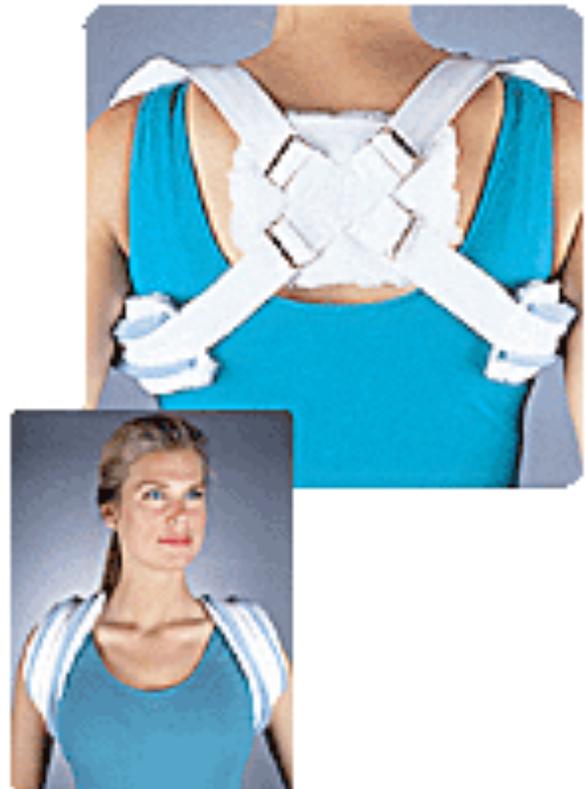
Figure 2. Clavicle harness

Non-surgical treatment for this fracture reduces the pain substantially. Some people are able to function at a desk with that arm by three weeks. Often the clavicle harness (figure 2) is used for four weeks (children) to six weeks (adults). Additionally, a broad arm sling may be recommended, worn outside the

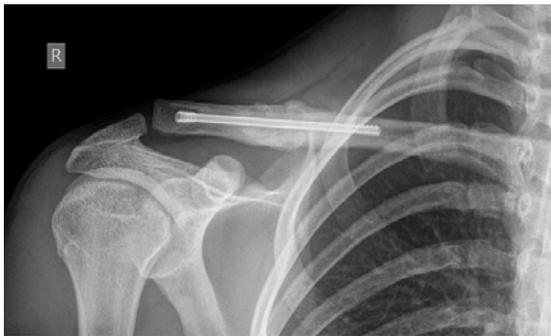
Figure 3. A 4.5mm x 90mm Herbert screw inside the clavicle

Operative management for these fractures could be by plate fixation. However, more commonly, a screw is placed down the inside of the bone. To do this, an incision is made directly over the break, a drill used to establish the “intramedullary” canal, a guide wire driven out through a separate incision behind the shoulder, back down the bone, then a hollow screw inserted over the top of the wire (figure 3). The break is usually then rigid enough that sports training can resume in one to two weeks, and full activity by six.

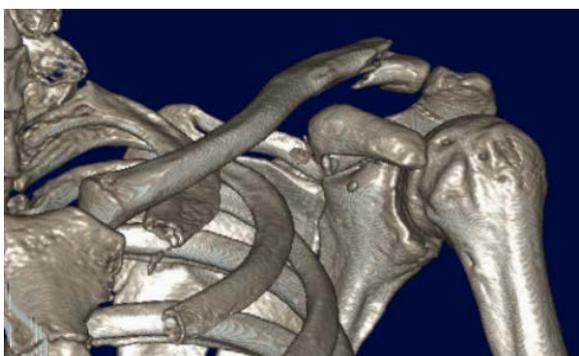
Figure 4. CT 3D reconstruction of lateral fracture

These are a notoriously difficult group. Sling treatment has a high non-union rate, causing ongoing pain and disability. The location usually means the ligaments have either been stripped off the clavicle, or the fracture occurs adjacent to the ligaments. The medial aspect of the bone is then pulled high by the muscles that support the shoulder girdle. There is often a large gap and excessive movement, factors that prevent fracture union.
